A preliminary investigation of the physical features and the physicochemical and microbiological parameters of natural springs found in Linden, Guyana

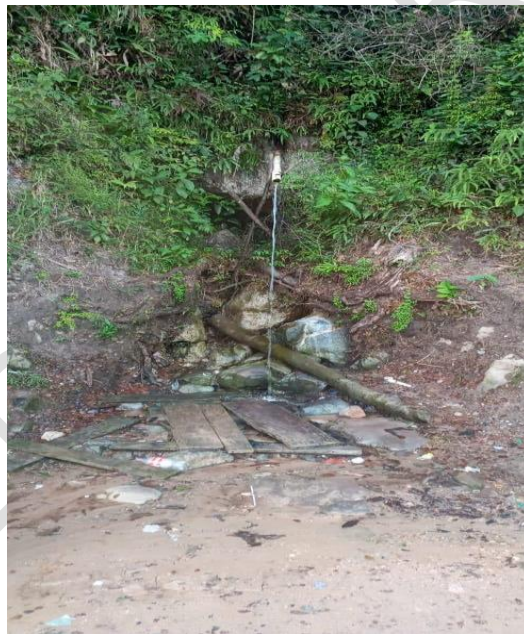
**Figure 2: Coomacka Spring in Linden**

This spring had indications of nearby pollution (Figure 2). The site displayed hilly terrain with nearby isolated settlements. The spring water was clear. There appeared to be dense vegetation types with mixed soil types of sand, rocks, and loam.

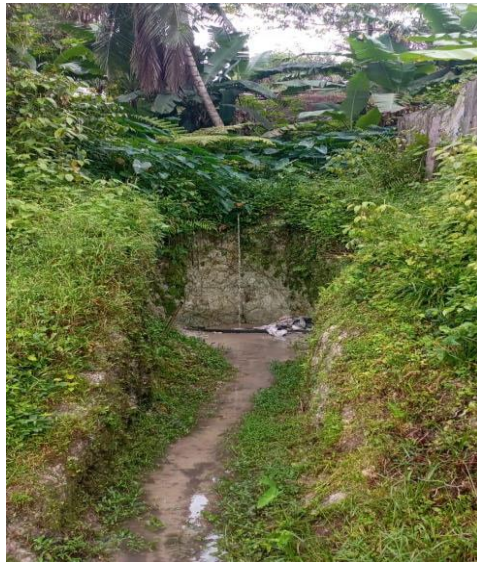
**Figure 3: Blueberry Hill Spring in Linden**

This spring bore dense vegetation types with mixed soil type (sand and clay) (Figure 3). Settlements were dispersed nearby. Pollution was absent.

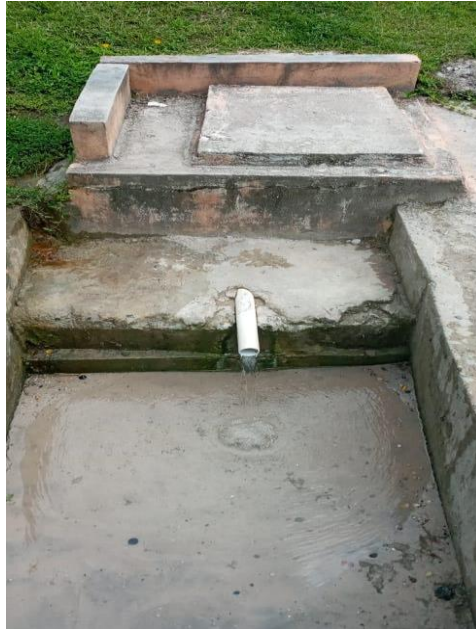
**Figure 5: Silvertown Spring, Linden**

Vegetation Type is sparse and soil type is sandy (Figure 5). The terrain was hilly. Settlements were found to be linear. There was no pollution noted.

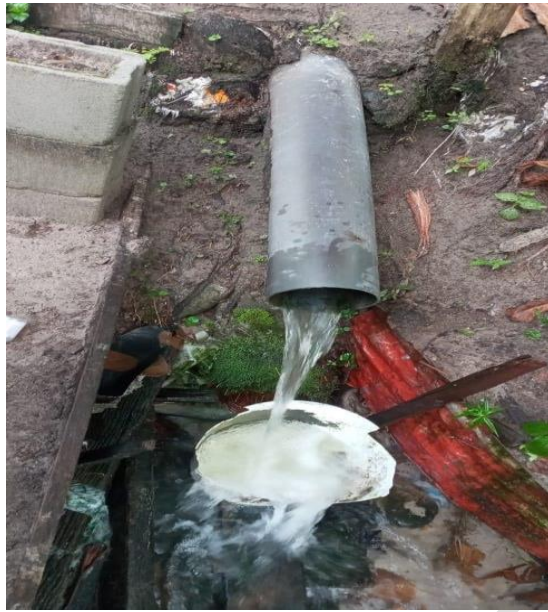
**Figure 6: Victory Valley Spring, Linden**

There was no vegetation type at the location (Figure 6). Soil type of sandy and hilly terrain. Settlements were dispersed and pollution absent.

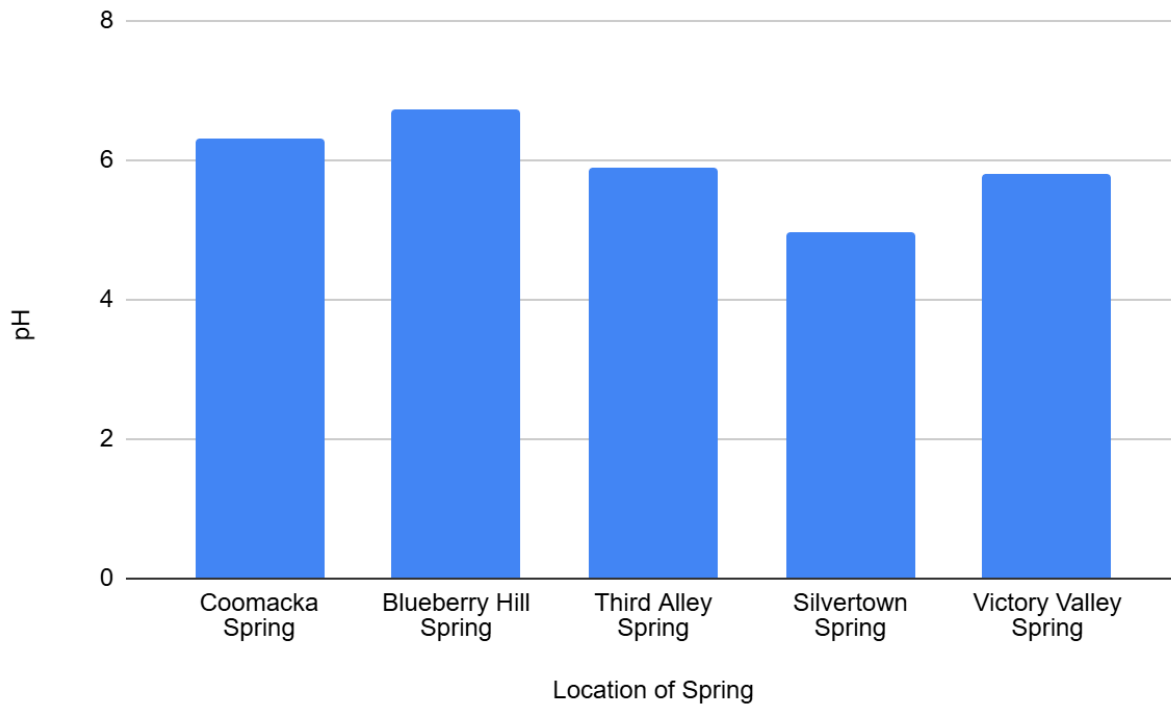
**Figure 9: Comparison of pH of springs**

Water with a pH between the range of 6.5 to 8.5 is usually deemed acceptable. The pH levels of the water samples were found ranging from 4.98 to 6.74 (Figure 9). The Silvertown spring water sample recorded the lowest pH value of 4.98, while the Blueberry Hill spring water sample recorded the highest pH value of 6.74.

Four of the springs investigated samples were slightly acidic, and were reported to be below the minimum permissible level (6.5) established by the World Health Organization (WHO). Long-term subjection to pH below the permissible limit can cause blood acidity. pH decrease can be attributed to events such as acid rain caused by CO<sub>2</sub> in the atmosphere as well as other air pollutants, the bedrock and soil composition through which rainwater flows, waste water/agricultural/industrial/mining operation runoff and degradation of plant materials [12].
