A preliminary investigation of the physical features, ~~and the~~ physicochemical and microbiological parameters of natural springs found in Linden, Guyana

Keywords: Spring, Water quality, Coliform, Guyana, Linden

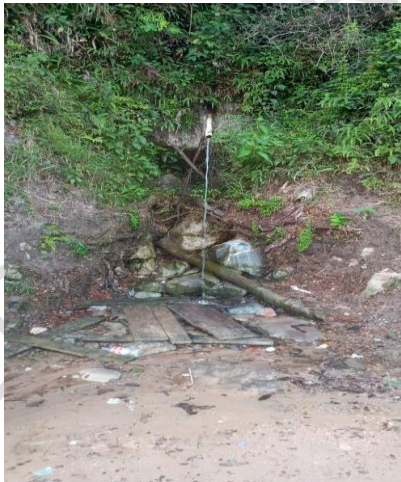
Figure 2: Coomacka Spring in Linden

This spring had indications of nearby pollution (Figure 2). The site displayed hilly terrain with nearby isolated settlements. The spring water was clear. There appeared to be dense vegetation types with mixed soil types of sand, rocks, and loam.

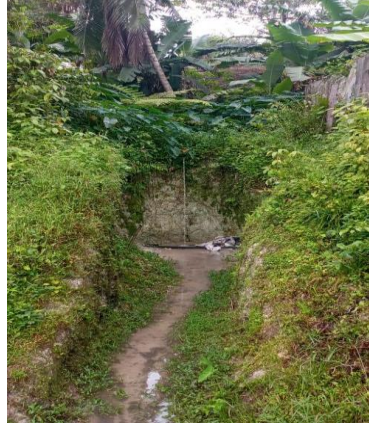
Figure 3: Blueberry Hill Spring in Linden

This spring bore dense vegetation types with mixed soil type (sand and clay) (Figure 3). Settlements were dispersed nearby. Pollution was absent.

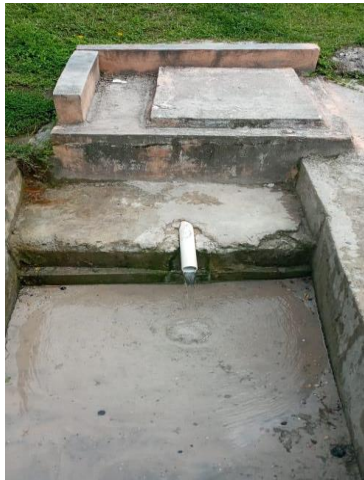
Vegetation Type is sparse and soil type is sandy (Figure 5). The terrain was hilly. Settlements were found to be linear. There was no pollution noted.

Figure 5: Silvertown Spring, Linden

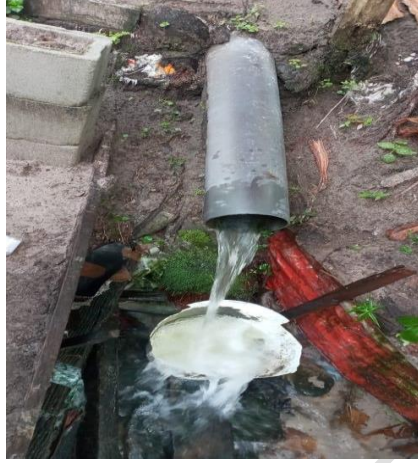
Figure 6: Victory Valley Spring, Linden

There was no vegetation type at the location (Figure 6). Soil type of sandy and hilly terrain. Settlements were dispersed and pollution absent.

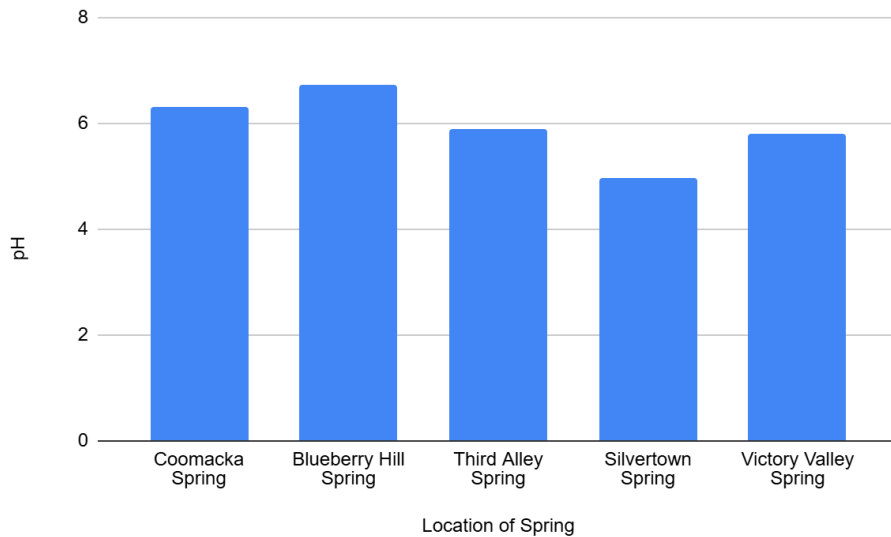
Water with a pH between the range of 6.5 to 8.5 is usually deemed acceptable. The pH levels of the water samples were found ranging from 4.98 to 6.74 (Figure 9). The Silvertown spring water sample recorded the lowest pH value of 4.98, while the Blueberry Hill spring water sample recorded the highest pH value of 6.74.

Figure 9: Comparison of pH of springs

Four of the springs investigated samples were slightly acidic, and were reported to be below the minimum permissible level (6.5) established by the World Health Organization (WHO). Long-term subjection to pH below the permissible limit can cause blood acidity. pH decrease can be attributed to events such as acid rain caused by CO₂ in the atmosphere as well as other air pollutants, the bedrock and soil composition through which rainwater flows, waste water/agricultural/industrial/mining operation runoff and degradation of plant materials [12].

Overall results revealed that the Silvertown spring is the only potable spring (20%) among those tested. Both the spring's physicochemical and microbial parameters (except pH) were found to be in conformity with the recommended standards established by the World Health Organization (Figure 9). Though the water recorded a low pH value, this water can still be consumed due to the
