## A preliminary investigation of physicochemical and microbiological parameters of natural springs found in Linden, Guyana

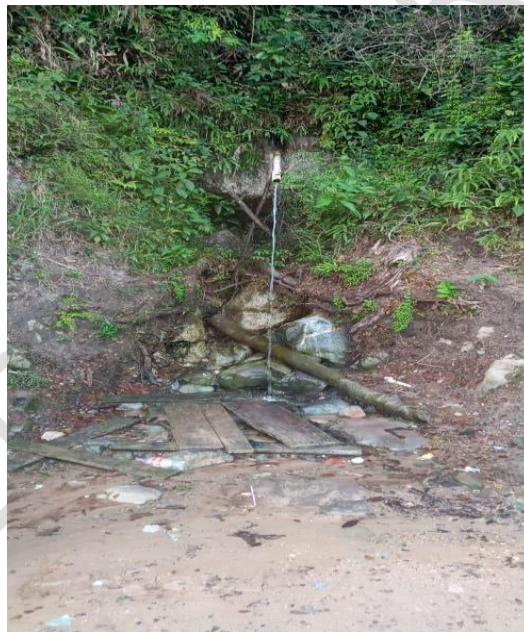
**Figure 2: Coomacka Spring in Linden**

This spring had indications of nearby pollution (Figure 2). The site displayed hilly terrain with nearby isolated settlements. The spring water was clear. There appeared to be dense vegetation types with mixed soil types of sand, rocks, and loam.

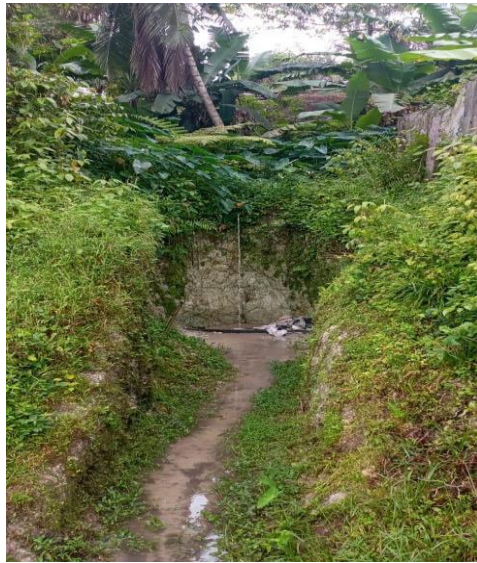
**Figure 3: Blueberry Hill Spring in Linden**

This spring bore dense vegetation types with mixed soil type (sand and clay) (Figure 3). Settlements were dispersed nearby. Pollution was absent.

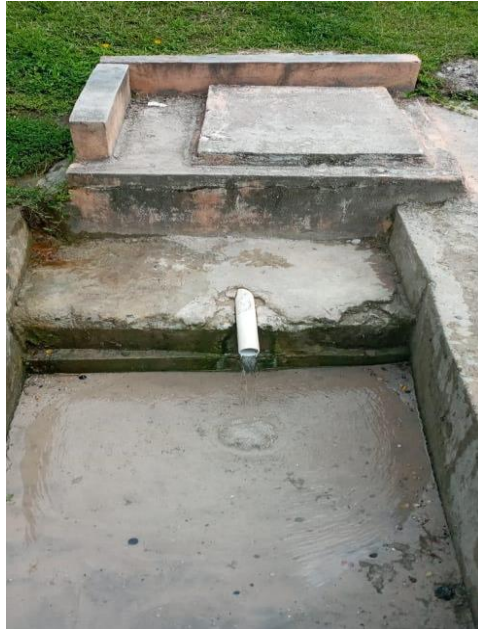
**Figure 5: Silvertown Spring, Linden**

Vegetation Type is sparse and soil type is sandy (Figure 5). The terrain was hilly. Settlements were found to be linear. There was no pollution noted.

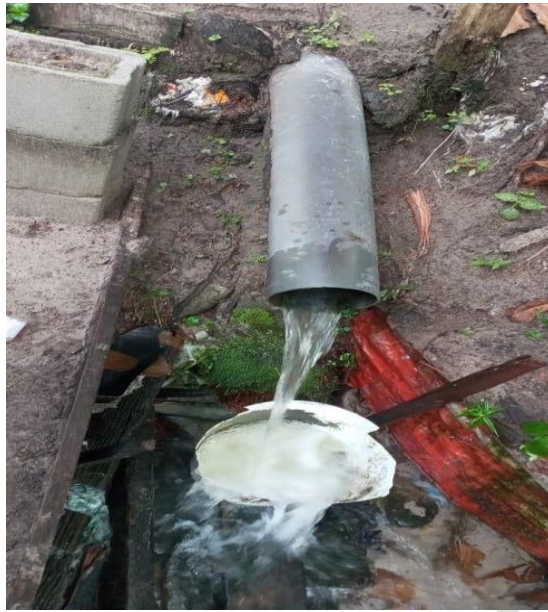
**Figure 6: Victory Valley Spring, Linden**

There was no vegetation type at the location (Figure 6). Soil type of sandy and hilly terrain. Settlements were dispersed and pollution absent.
